# Mark 20 Category II/III Instrument Landing System Operational Test and Evaluation, Functional and Performance Test Report

October 1995

DOT/FAA/CT-TN95/44

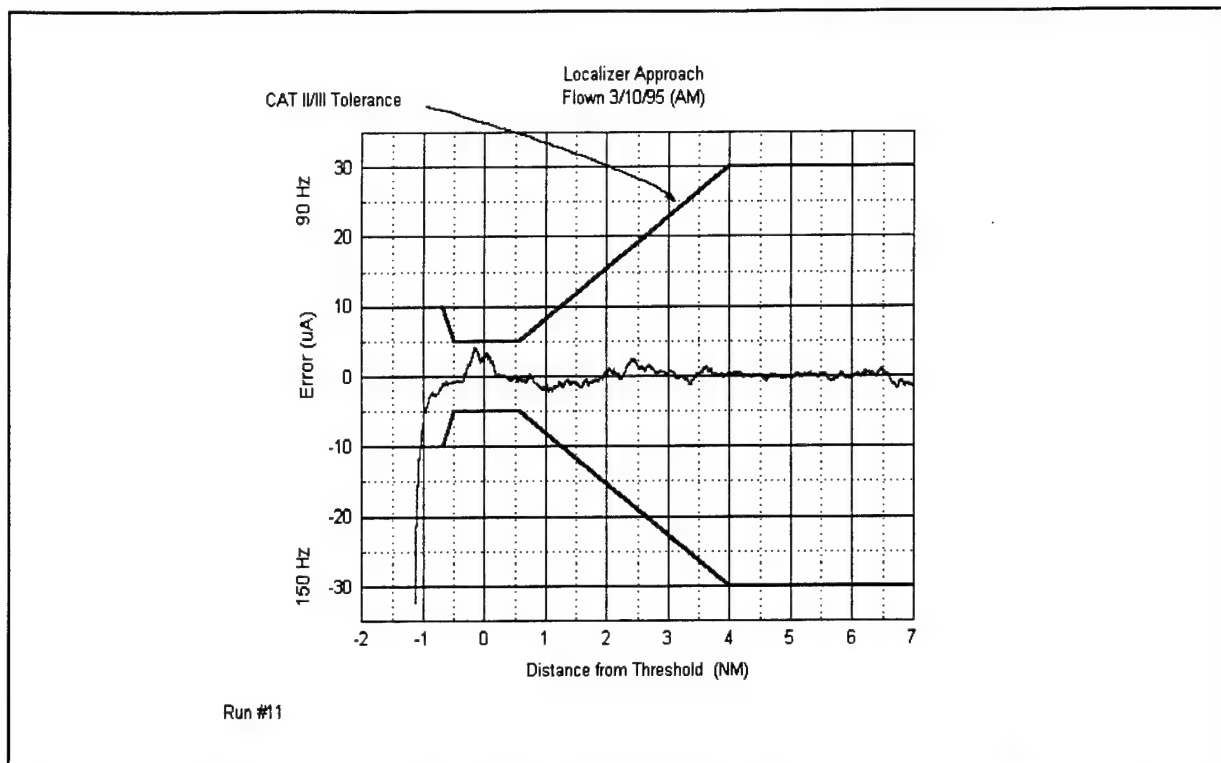
FIGURE 4. LOCALIZER APPROACH GUIDANCE ERROR PLOT

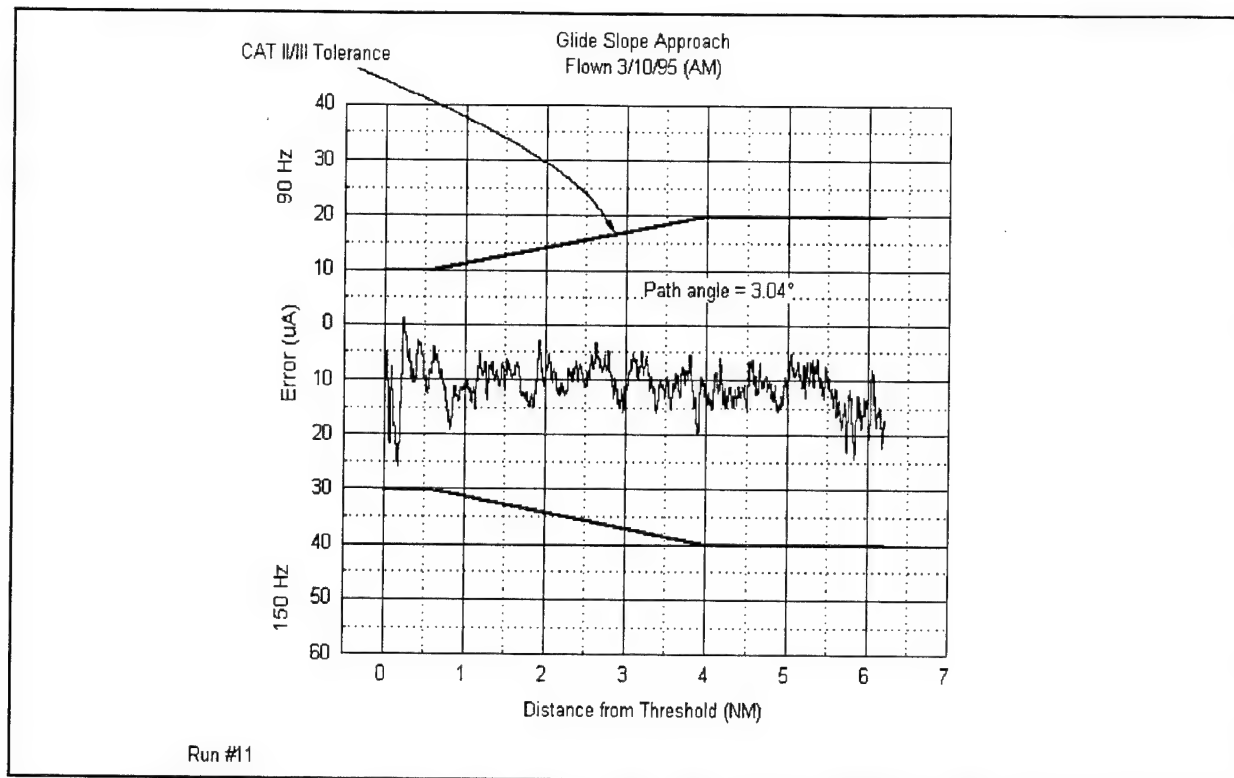
FIGURE 6. GLIDE SLOPE APPROACH GUIDANCE ERROR PLOT

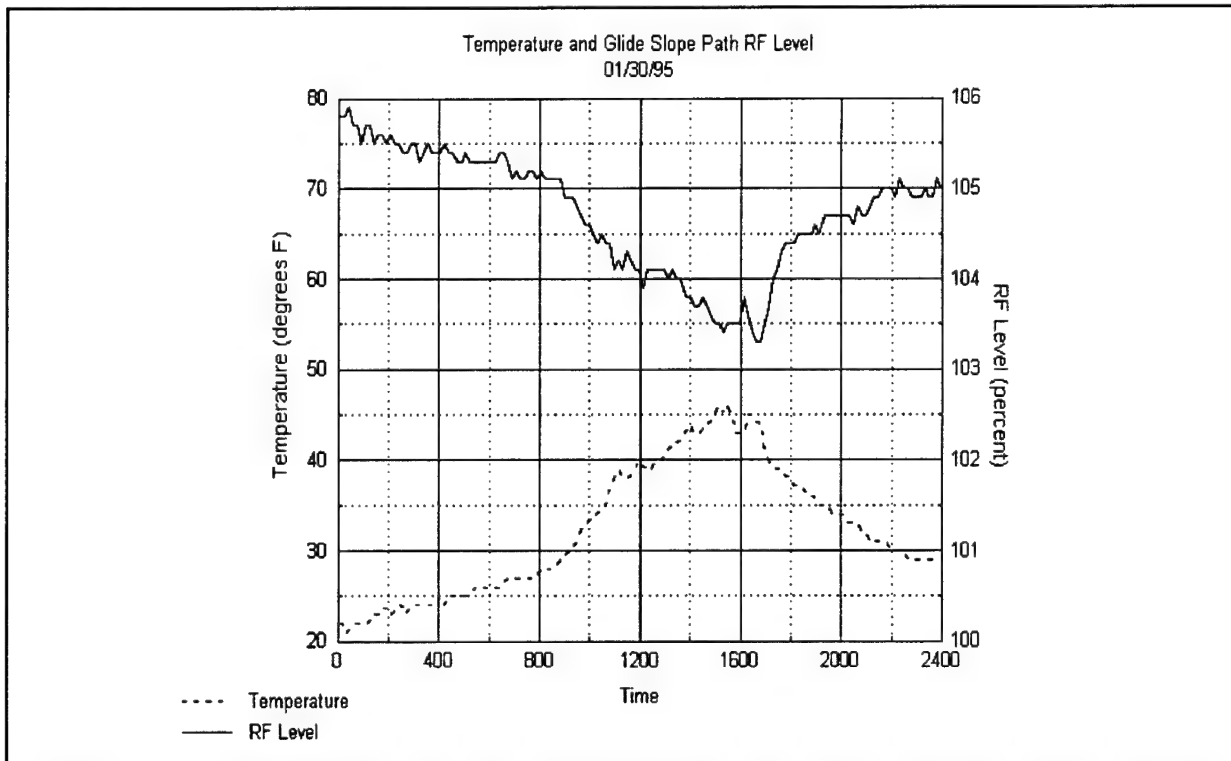
The only observed correlation between weather and the Mark 20 performance was temperature, and the course and clearance RF power for the localizer and glide slope. This correlation shows an approximate 2 percent change in RF level to a 20° Fahrenheit change in temperature. This change is relatively insignificant but could be a problem depending on the recalibration schedule. The monitors were calibrated at the test site during the summer months. Due to the change in average temperature during the winter months, the average RF levels were in the vicinity of 104 percent. The daily fluctuation in temperature varied the RF levels between 103 percent and 106 percent. At facilities with colder winter temperatures, a subsystem calibrated during the summer may drift out of RF level tolerance during the winter and vice versa. Only output power of the subsystem is affected as the impedance characteristics of exposed cable and antennas change with the temperature. This condition will not affect the quality of guidance because Carrier and Sidebands (CSB) and SBO signals are attenuated at the same rate, but some outages could occur due to RF levels exceeding alarm limits. Figure 8 shows the temperature and glide slope path RF level for January 30, 1995. The monitored weather and Mark 20 parameters for the month of January 1995 are contained in appendix C.

FIGURE 8. CORRELATION OF TEMPERATURE AND MONITORED GLIDE SLOPE PATH RF LEVEL FOR JANUARY 30, 1995

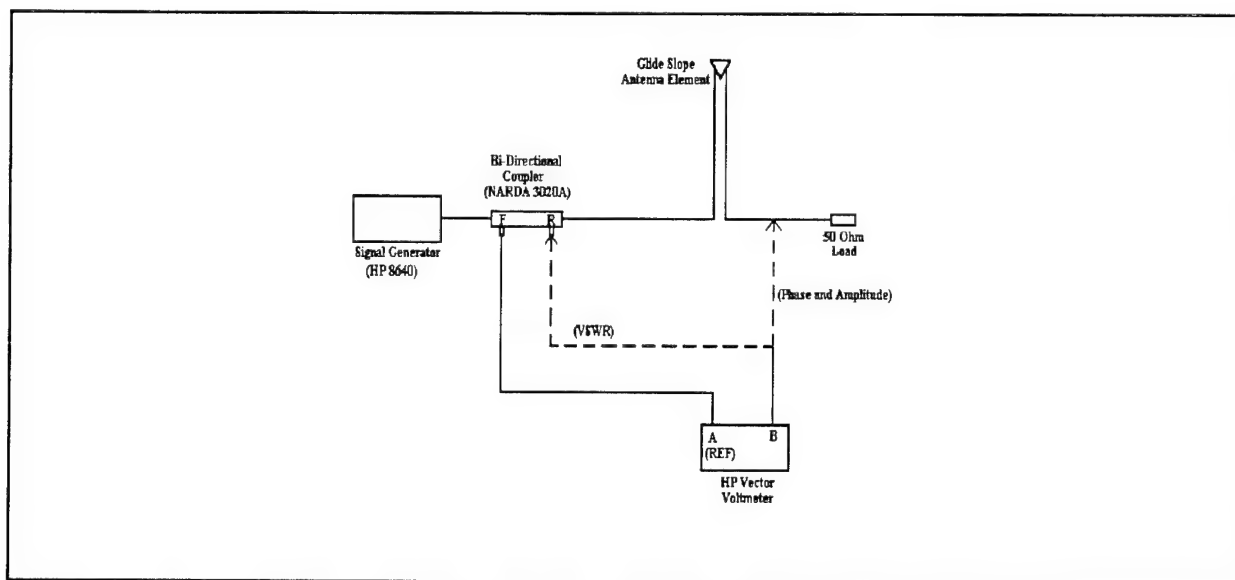
Figure 9 shows the configuration for testing ice loading effects. Table 1 indicates the date, time, conditions, VSWR, phase, and magnitude of the measurements made on the antennas. This data indicates that no significant changes in measured parameters were observed during ice loading or antenna heater operation. The maximum variations from the baseline measurements were: VSWR: 0.03, Phase: 1.3°, and magnitude: 0.28 dB. Based on these measurements, it appears that the antenna heaters are not required. The data collected also indicates that antenna heater operation does not affect the radiated signal. During this testing period (8 months) no antenna heater failures occurred. Because the glide slope electronic equipment had not been delivered at the time of this test, these measurements were obtained using a signal generator for the provided signal, thus no signal in space measurements were possible and no determination of actual provided guidance can be made.

FIGURE 9. TEST CONFIGURATION FOR MEASURING VSWR, PHASE, AND AMPLITUDE OF GLIDE SLOPE ANTENNAS DURING ICE LOADING TESTING

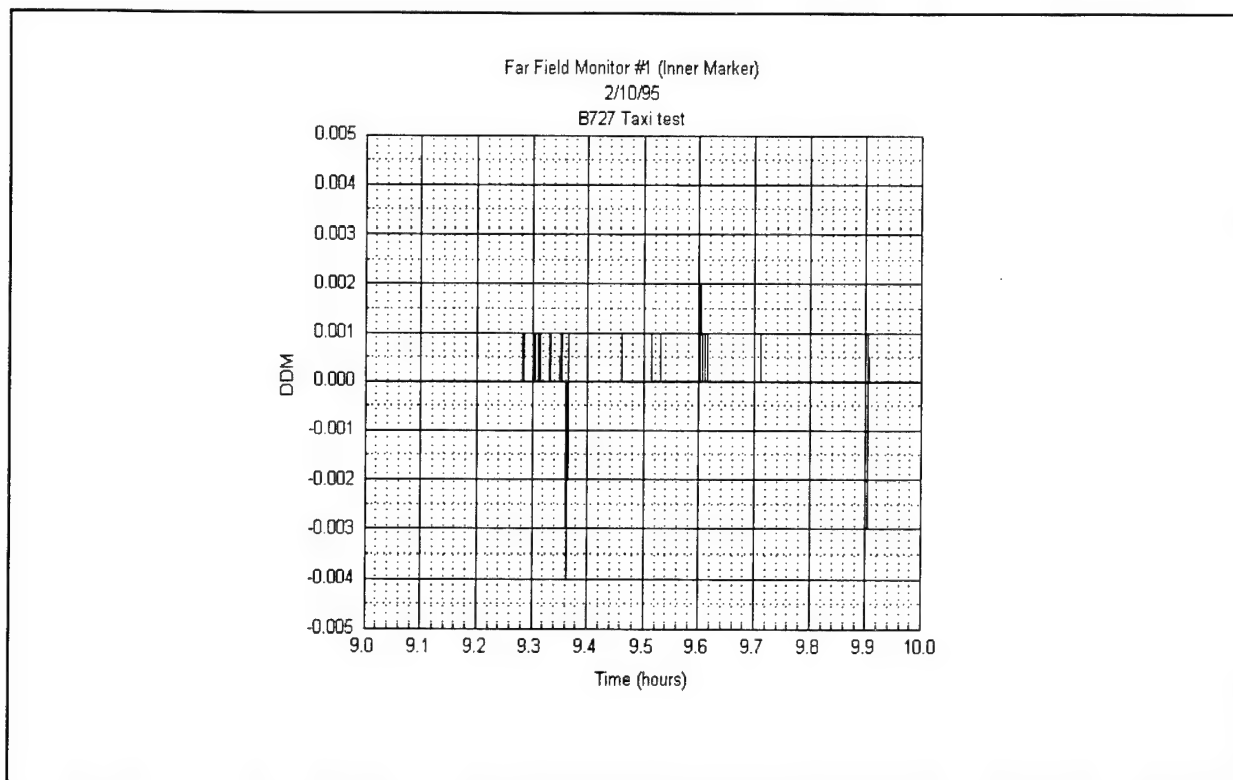
FIGURE 10. FAR FIELD MONITOR #1 READINGS WITH A B727 IN THE LOCALIZER ENVIRONMENT

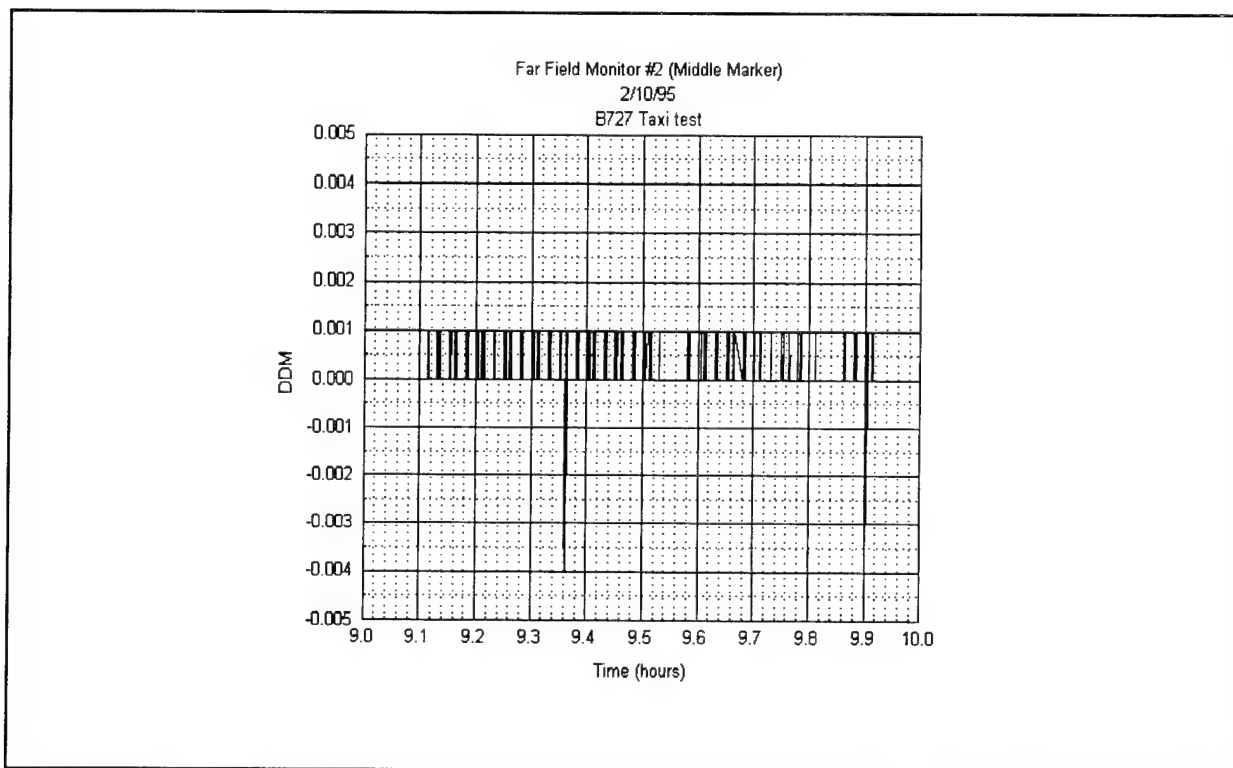
FIGURE 11. FAR FIELD MONITOR #2 READINGS WITH A B727 IN THE LOCALIZER ENVIRONMENT
